THE BENEFITS OF SHADE-CLOTH COVERS FOR POTABLE WATER STORAGE

Dr Niall Finn
Scott Barnes

CSIRO TEXTILE & FIBRE TECHNOLOGY

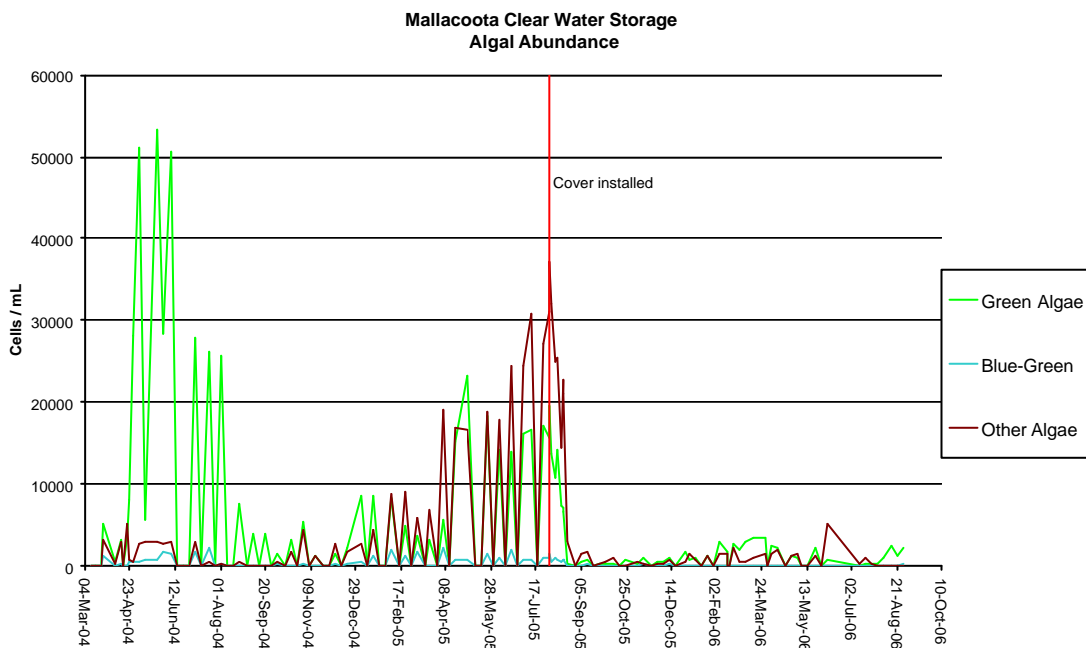
Figure 1. Mallacoota algal abundance showing large decrease in activity after covering.

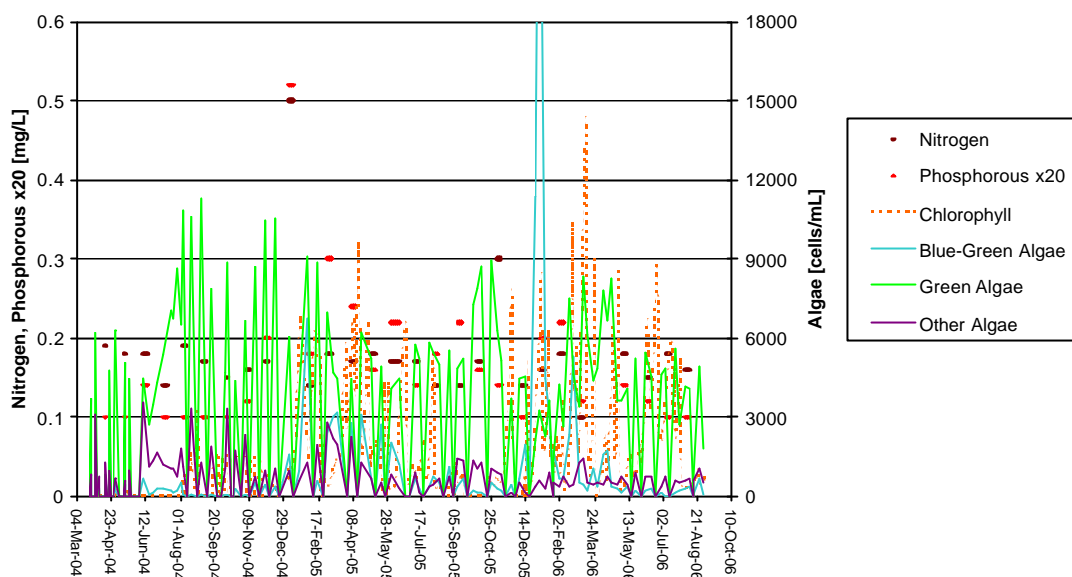
Figure 2. Sarsfield Basin was not covered for the whole period of the study and shows high algal activity in both the period before the other basins were covered and afterwards indicating that the changes that occurred with covering were not due to seasonal variations.

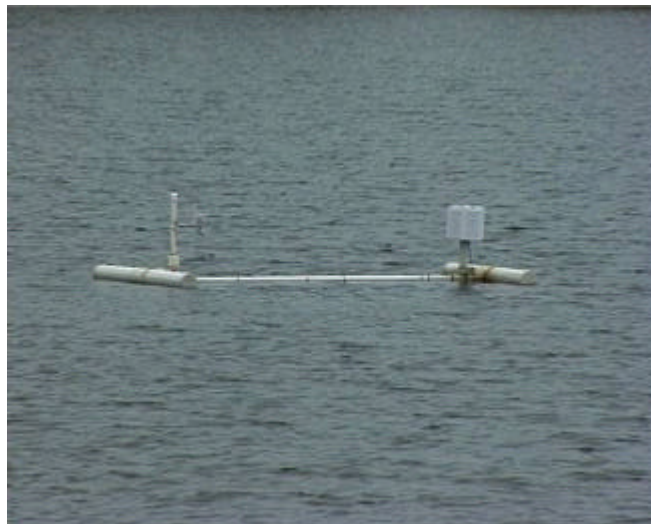
Figure 3. *Floating Weather Station*

Evaporation rates appear to be dramatically reduced. Pan evaporation was measured at each site remote from the basin but next to the land weather station, while evaporation from the basin was calculated using the data measured by the floating weather station on the water (Figure 3). The model used to calculate basin evaporation is a well established bulk aerodynamic method [1] that uses air temperature and humidity, water surface temperature and wind speed to calculate the evaporation rate. A fitting parameter was adjusted using the measured annual pan evaporation rate for the site and then this parameter used in the calculation of basin evaporation rate using the weather and water temperature data obtained on the water. Annual evaporation rate estimates ranged from 870 mm to 1060 mm per year across the sites (see Table 1). At Mallacoota (Figure 4), the largest covered basin, the estimated evaporative loss is equivalent to 8.5 ML of water per annum. Directly measured pan evaporation rates ranged from 660 mm to 1025 mm across the sites. A definitive measurement of pre-cover versus post-cover losses was not possible. Omeo was expected to be the ideal site where the evaporation model could be validated as it was a fully lined basin and so seepage was expected to be zero. However, a problem with the inflow meter meant that an accurate water balance wasn't possible. At all other sites losses are a combination of seepage, evaporation and operational losses and the losses are a small fraction of the total flows and so very accurate measurement of flows over long periods of time are required. The air speed under the covers is effectively

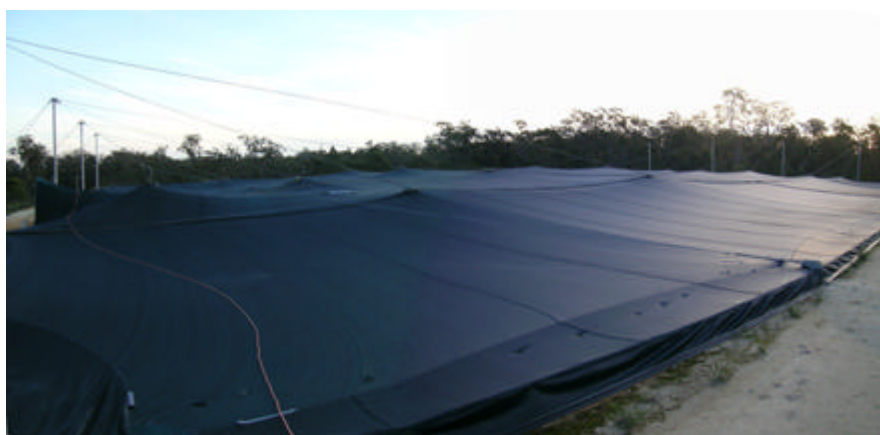
Figure 4. Mallacoota Clear Water Storage with cover

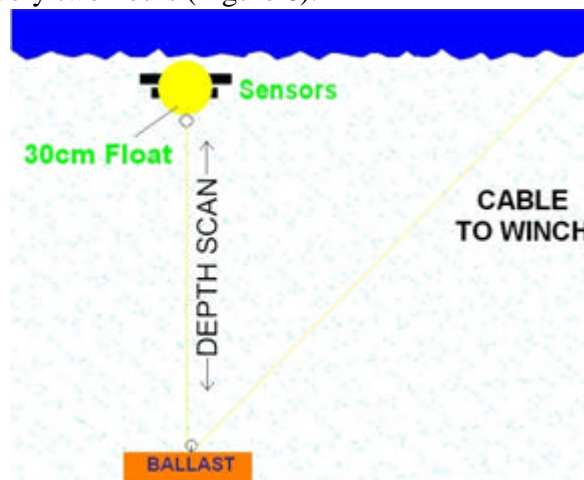
Installation of the main instruments was completed at five of the six sites before the end of March 2004. At the sixth site, Sarsfield, the Minisonde-Scufa water quality probe was not operational until April 20th as it failed and needed to return to the USA manufacturer for repair under warranty. The Minisondes had to be returned to the US manufacturer for repair on numerous occasions but four have been replaced with newer Datasonde devices, which have proved more reliable. The Datasondes and Minisondes are particularly useful in measuring variations on a short time-scale and variations with depth. At each site the “Scufa” (Minisonde or Datasonde devices) are mounted within a 30 cm polystyrene float connected by a stainless steel cable via a pulley at the bottom of each basin to a winch on the bank whose operation allows the instrument to be scanned slowly through the depth of the water, once every two hours (Figure 6).

Figure 6. Datasonde depth scanning mechanism.

This provides a profile for each of the water quality measures with depth. As algae (especially potentially toxic blue-green algae) are known to adjust their depth to the most favourable conditions it allows their detection even if they are occupying only a thin layer. It is also considered possible that when covered some basins would be more prone to stratification and the depth scans allowed temperature profiles to be measured.

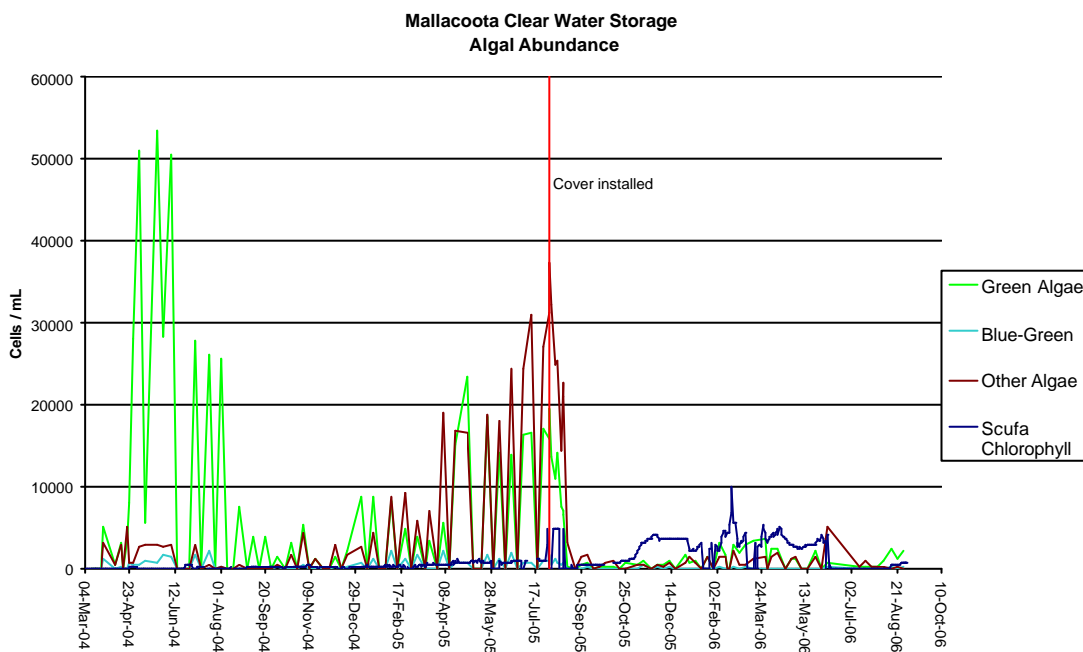
Figure 7. Mallacoota algal abundance, shows a dramatic reduction in algal blooms after covering.

Figures 7 – 9 below show the impact of covering the basin – reduced numbers of algal species and abundance as well as reduced bacterial levels indicating that reduced recontamination of the water after treatment has been achieved.

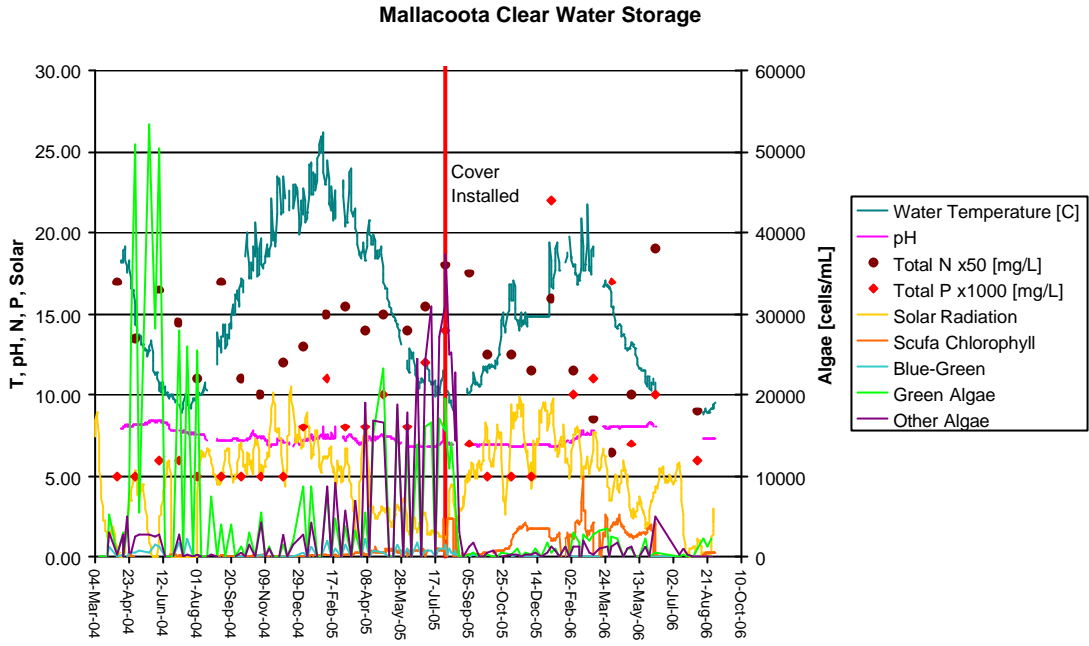
Figure 8. Mallacoota algal abundance with water temperature, pH, nutrient levels and solar radiation. Note that algal blooms can occur in winter when light levels and water temperatures are lower. This graph also shows that nutrient levels are not limiting growth since they are just as high after covering as before.

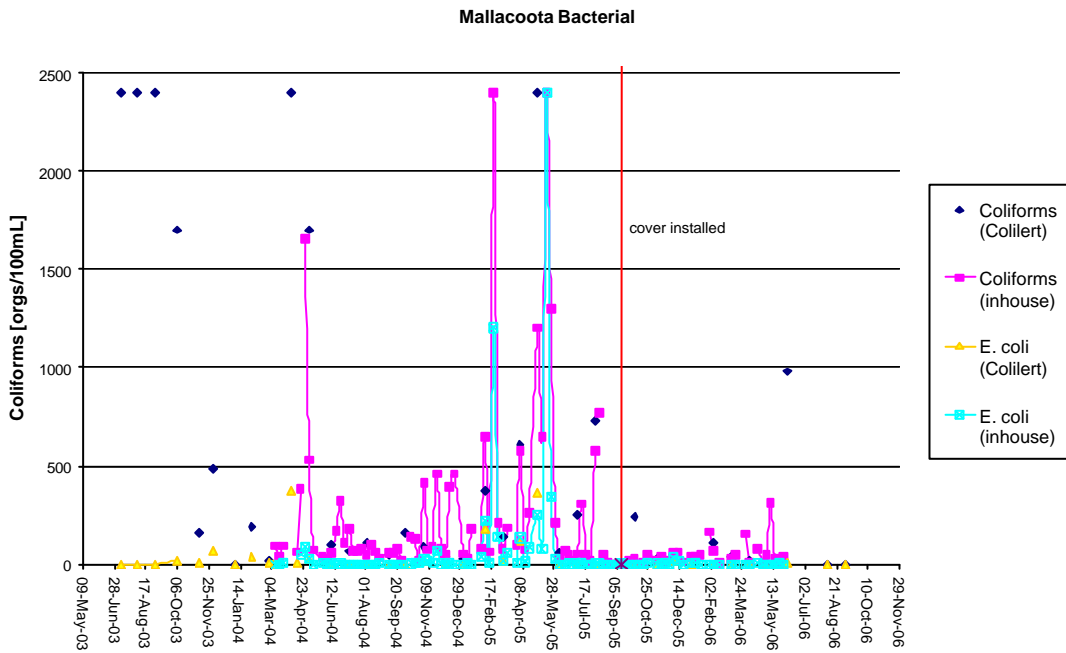
Figure 9. Mallacoota bacterial test results. Covering has reduced the frequency of bacterial contamination; probably due to the exclusion of water birds.

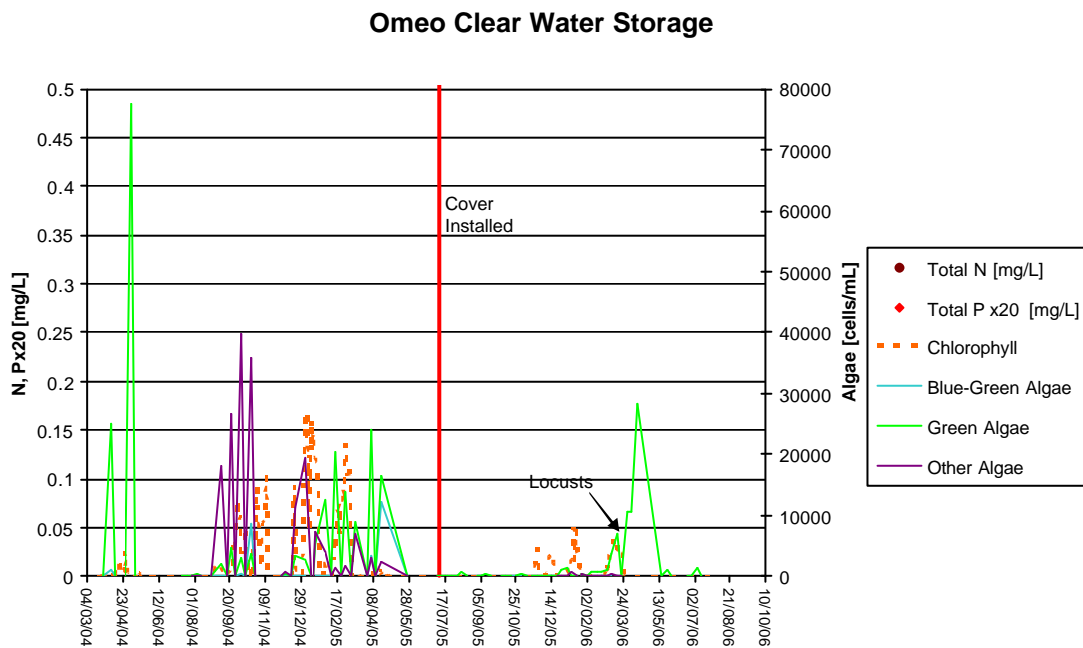
Figure 10. Omeo clear water storage algal abundance. High nutrient levels accompany periods of high algal growth. The short spike in green algae in April 2006 is anomalous and did not require any action.

Since being covered, and apart from the locust infestation, the Omeo storage has not suffered any algal or bacterial contamination that has required remediation such as algicide dosing or drainage and cleaning. The operations of the overall WTP have been enhanced due to the increased reliability of the storage (Figures 10-12).

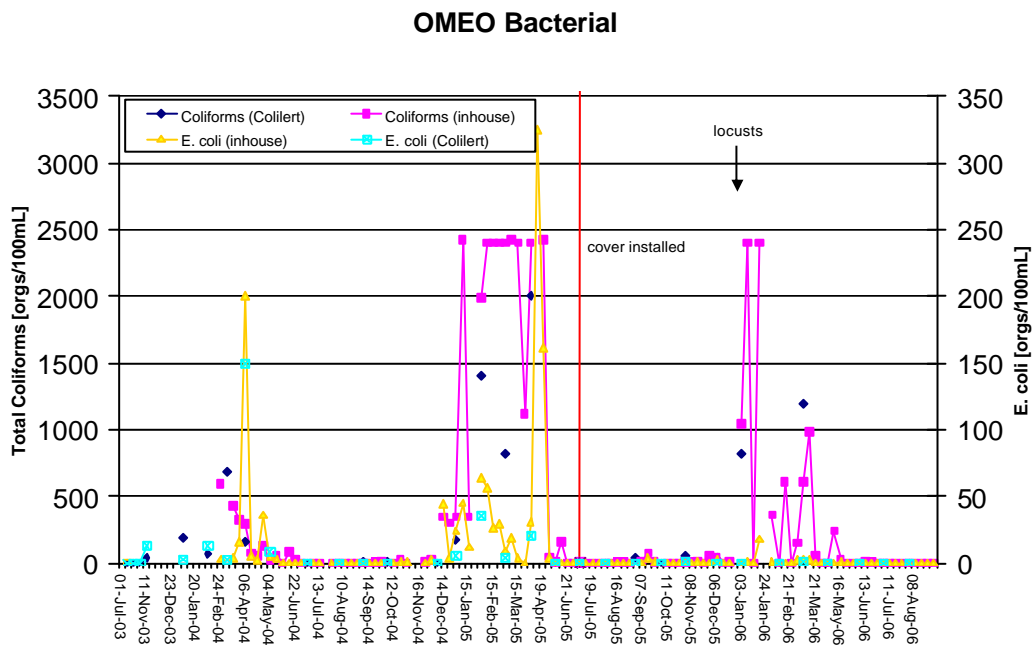
Figure 12. Omeo clear-water storage bacterial contamination. Note that the event in February-March 2006 was a locust infestation.

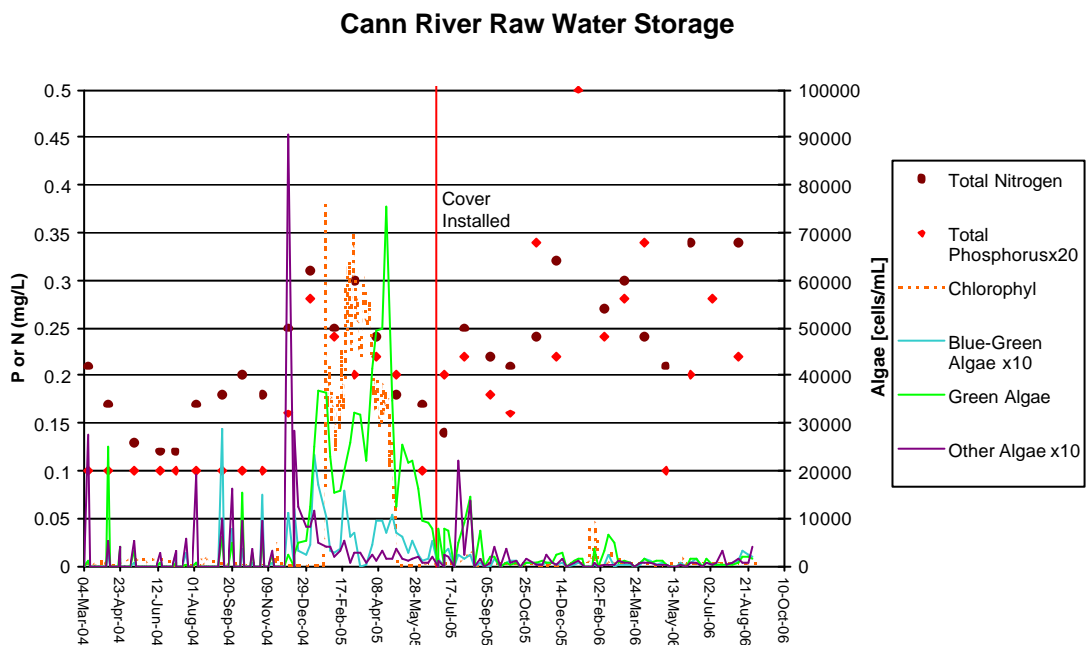
Figure 13. Cann River raw water storage algal abundance. Despite high nutrient levels since covering there have been no significant blooms.

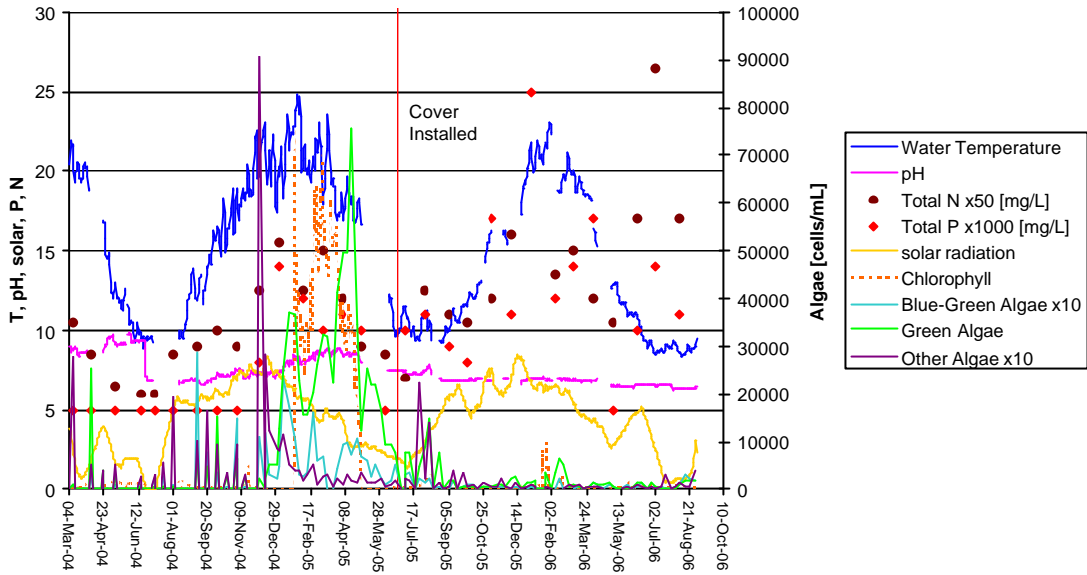
Figure 14. Cann River raw water storage algal abundance with water temperature, pH, nutrients and solar radiation. Despite warm weather and high nutrient levels no algal blooms occurred.

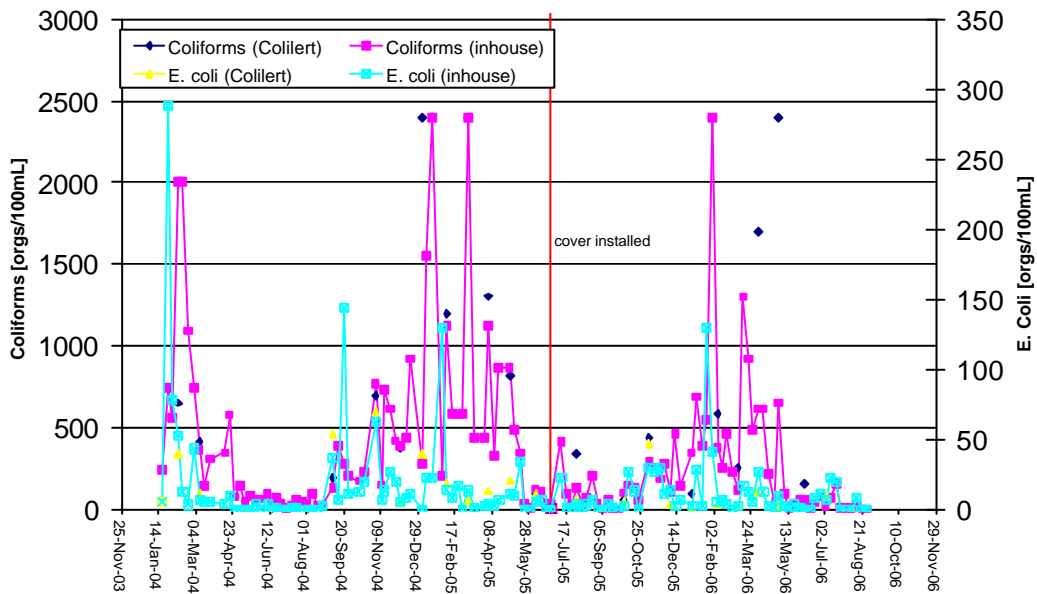
Figure 15. Cann River bacterial contamination. The cover has made little difference to the bacterial levels because this is a raw water storage and if the water source is contaminated then so will be the storage.

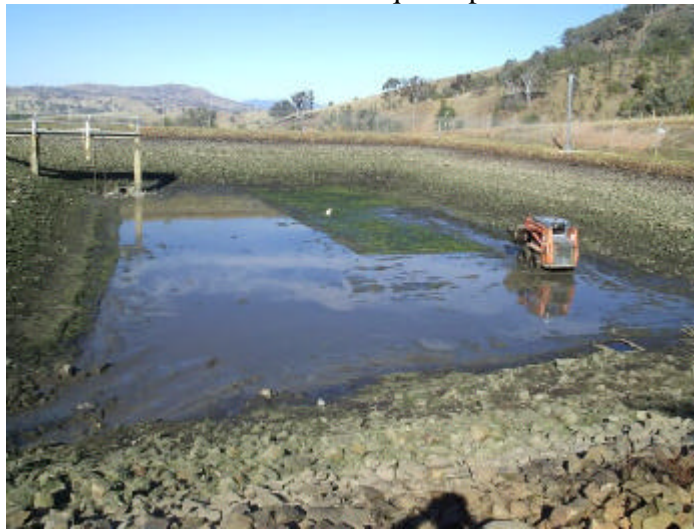
Figure 16. *Swifts Creek basin being cleared of aquatic plants*

Clearing of aquatic plants from water storages, as shown in Figure 16 above, is an expensive and inconvenient operation and the basin is off-line for several days.

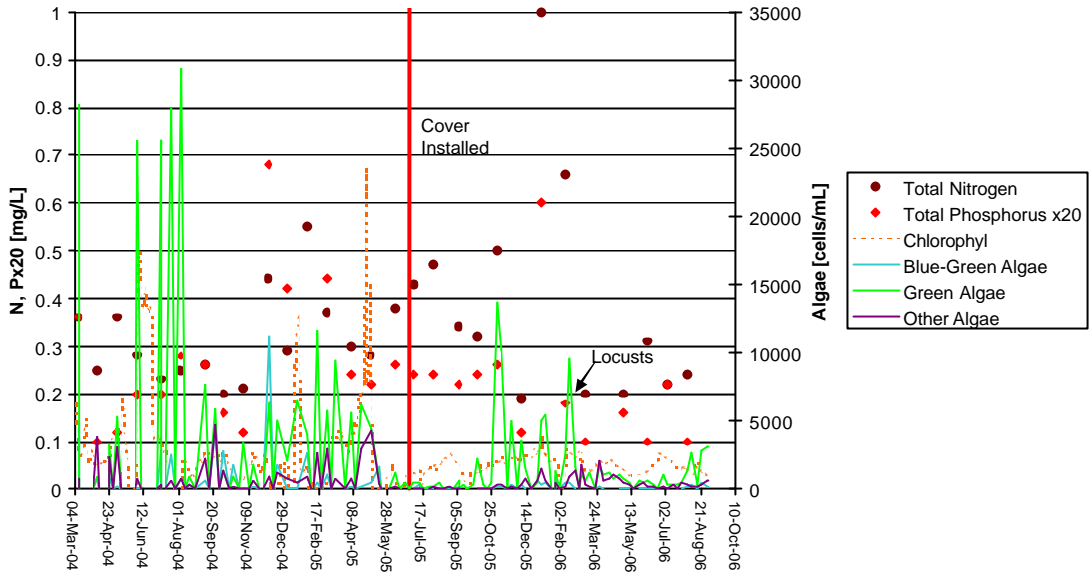
Figure 17. Swifts Creek raw water storage algal abundance. Note the presence of locusts ; Swifts Creek is only 20 km from Omeo and was impacted at the same time .

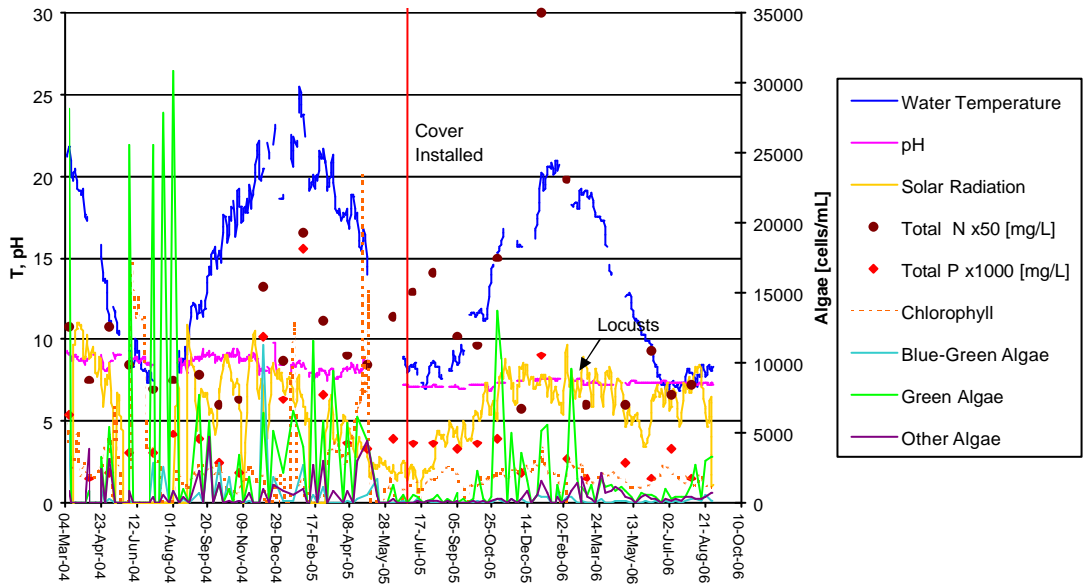
Figure 18. Swifts Creek algal abundance with water temperature, pH, and nutrients

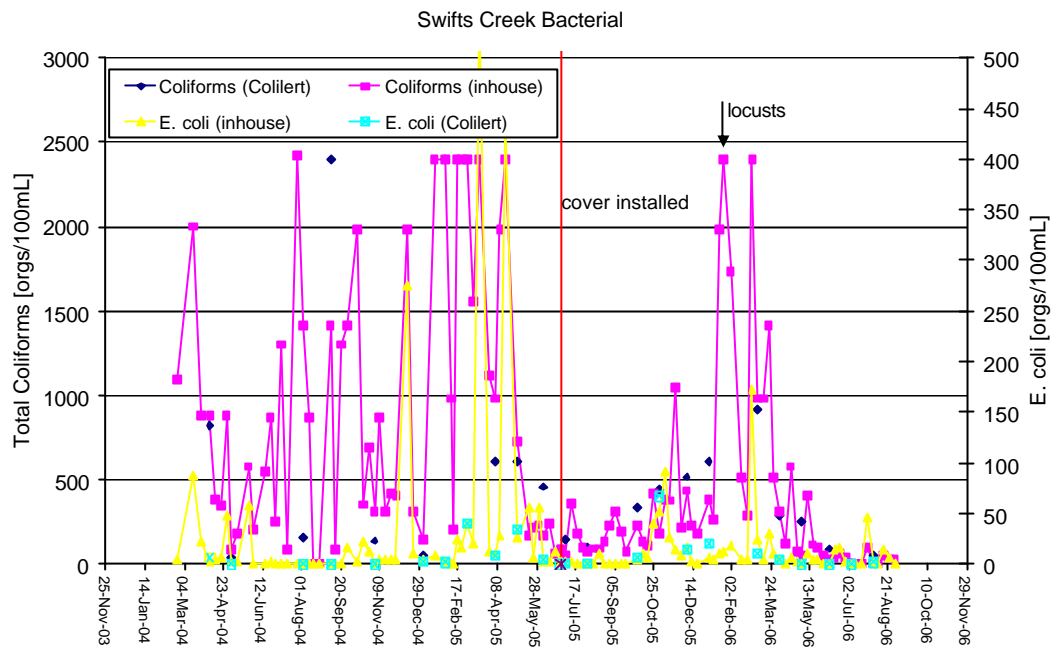
Figure 19. Bacterial levels at Swifts Creek were reduced by the cover but because it is a raw-water storage and the river is a source of contamination, significant levels still occurred after covering. The highest levels in the post-cover period coincided with the dead locusts.

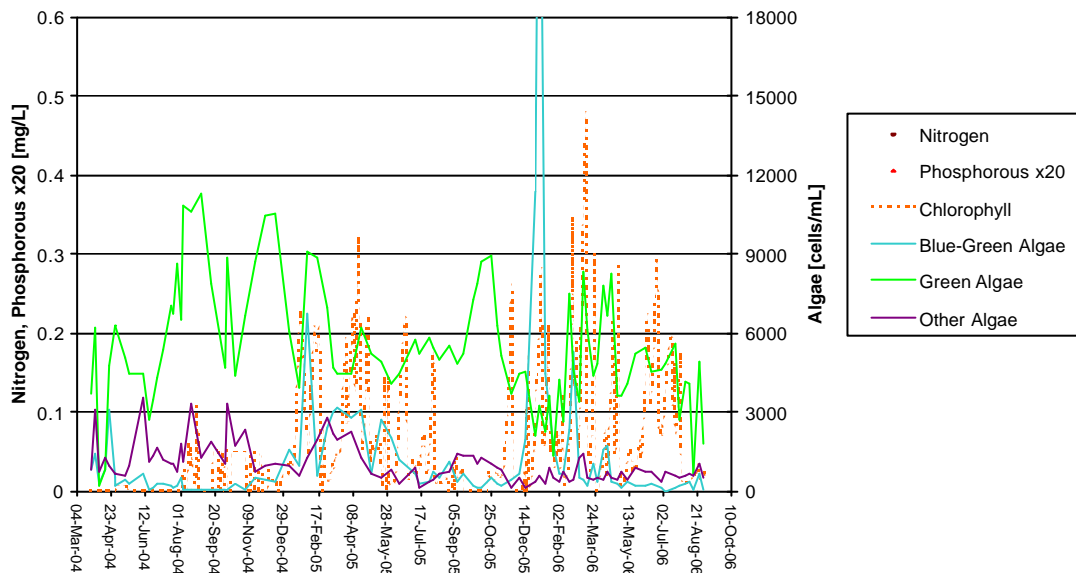
Figure 20. Sarsfield algal abundance.

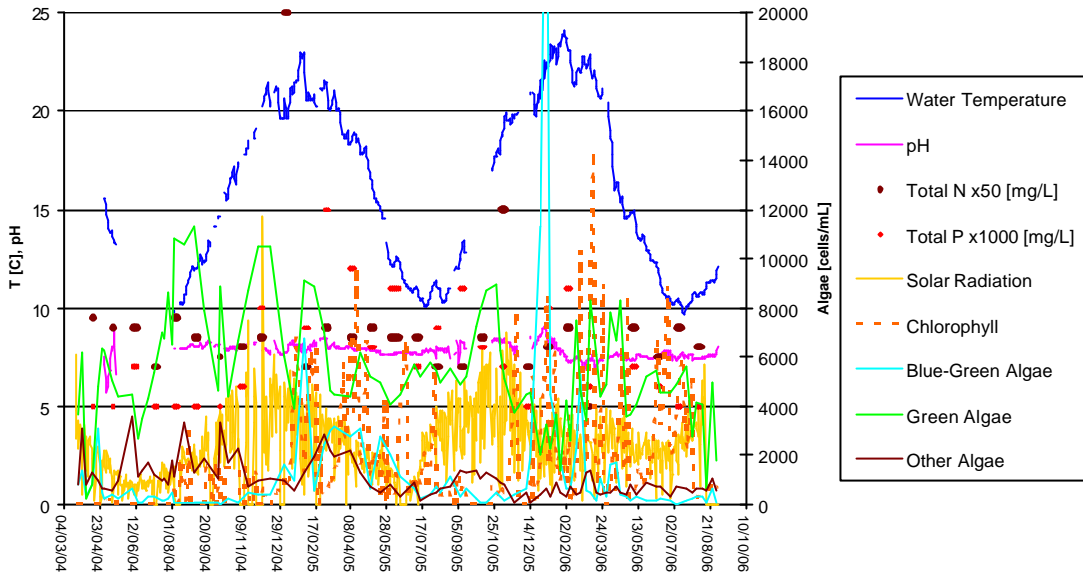
Figure 21. Sarsfield algae plotted with water temperature, pH, solar radiation, and nutrient levels.

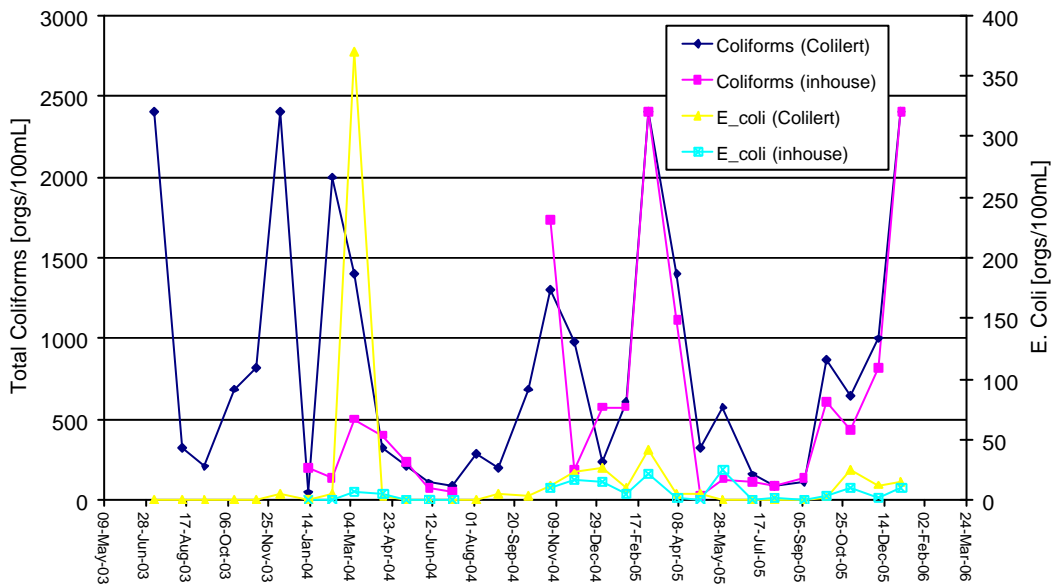
Figure 22. Sarsfield Bacteria results.

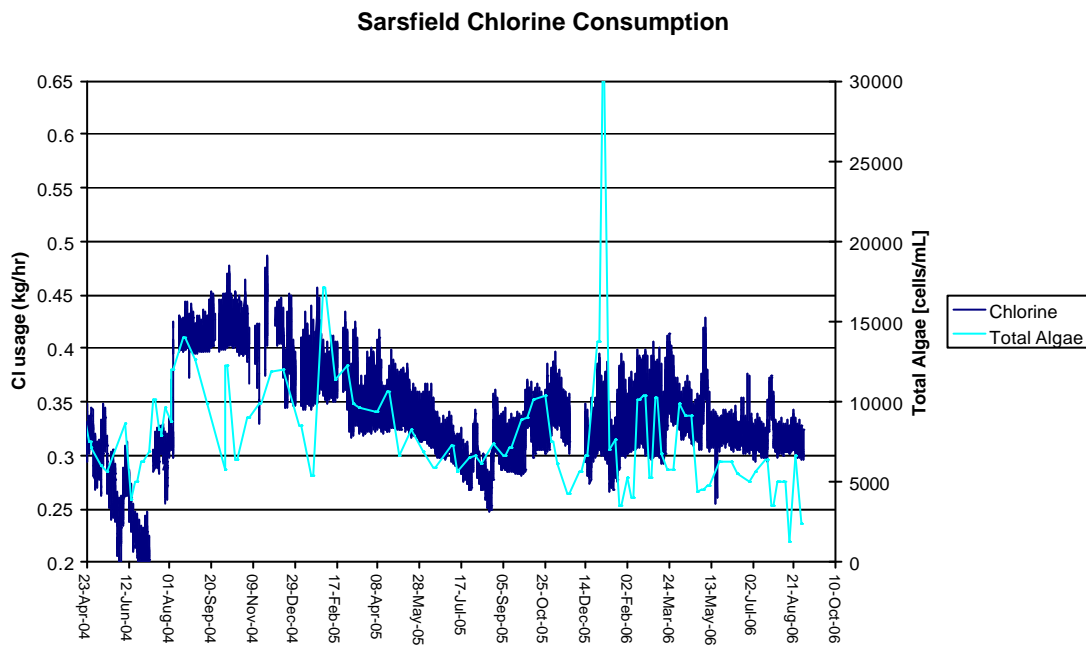
Figure 23. Chlorine usage at Sarsfield.

Figure 23 shows the rate of chlorine use. Gaseous chlorine is used as a disinfectant. The chlorine used per hour is plotted against the total algae test results. The chlorine injection is flow paced but is also mediated by the residual chlorine in the treated water so if there is more organic material present then more chlorine is required to maintain the residual level. It can be seen that the chlorine usage rate is somewhat linked to the algal abundance, suggesting that reduced algae would be expected to reduce the chlorine usage.

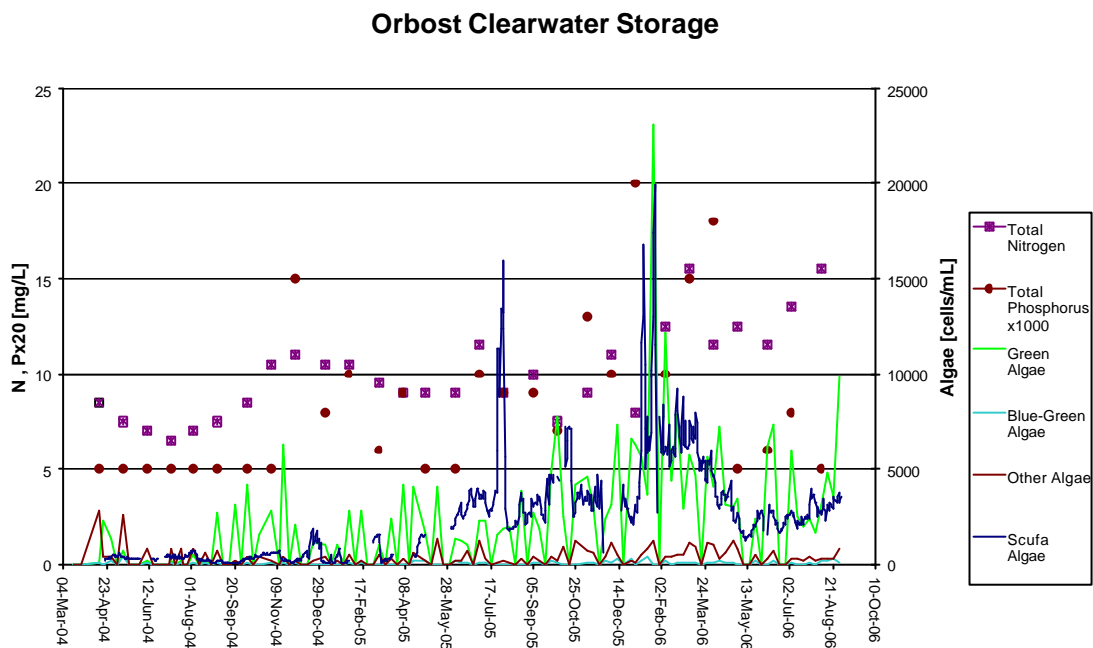
Figure 24. Orbost Algal abundance.

The township of Orbost is supplied with water harvested from the Brodribb River and Rocky River. This water is stored in a Raw Water Storage and undergoes full water treatment (coagulation / flocculation / sedimentation / filtration). The treated water is transferred to a Clear Water Tank which is chlorinated at the outlet prior to entry into the reticulation system. Overflow from the Clear Water Tank is stored in a 53 ML earthen, rock beached Clear Water Storage. During periods of high demand, this water is re-chlorinated prior to boosting supply into town. Orbost is the second “control” site; it was uncovered for the whole study (Figure 24-26).

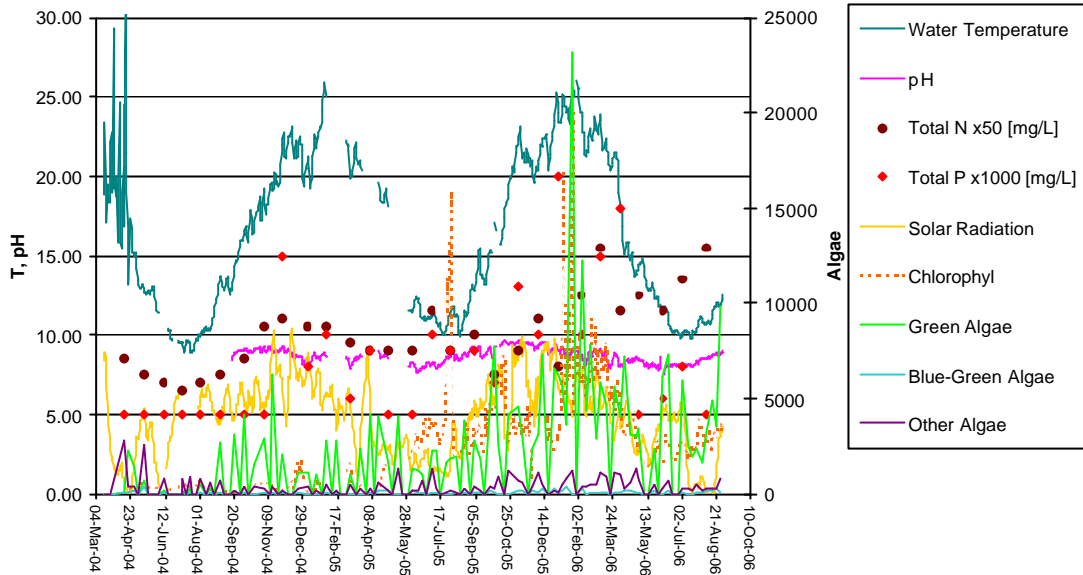
Figure 25. Orbost Algal abundance, water temperature, and pH.

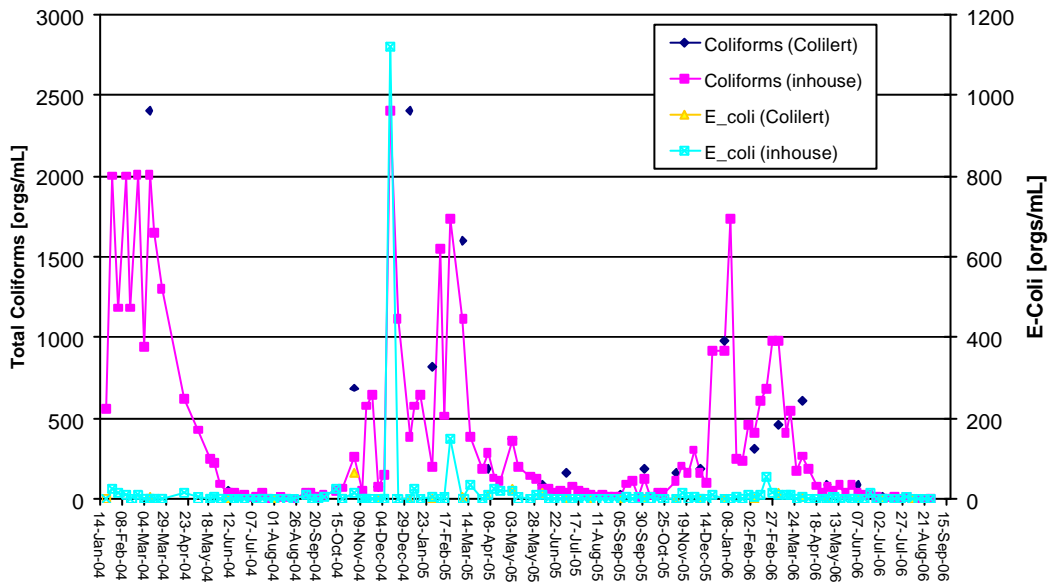
Figure 26. Orbost Bacterial test results.

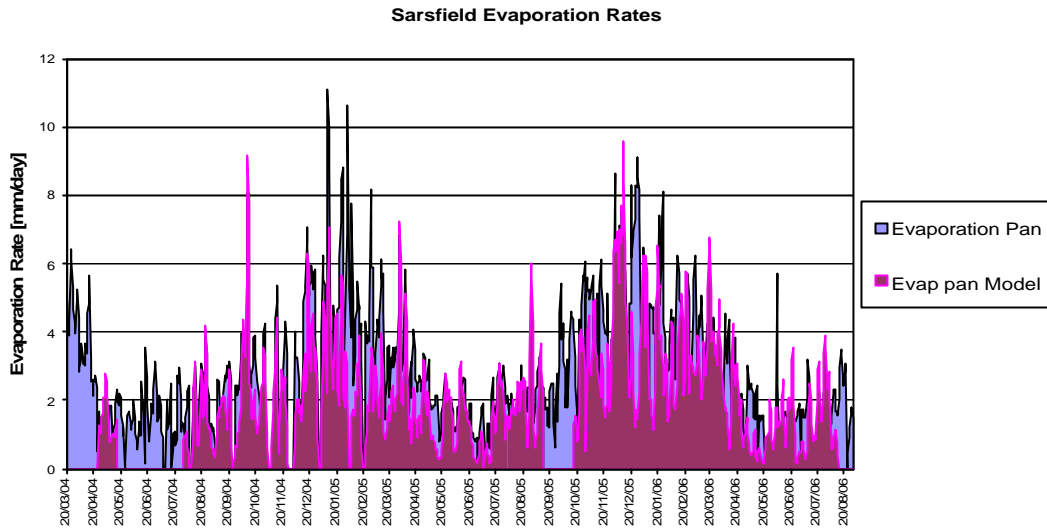
Figure 27. Evaporation pan measurements against model results. Gaps occur where data was not available. The agreement is reasonably good. The parameter k was adjusted to match the measured average pan evaporation from the study period and then the same value used to calculate the basin evaporation using wind speed and water temperature measured over water in the basin.

Z_o over the land was chosen to be 0.1 m and k was adjusted slightly for each site to match the calculated pan evaporation to the average measured pan evaporation with $h=1.8$ m, the height of the land based anemometer. This factor was then used but with $h=0.4$ m, the height of the on-water weather station, for calculation of basin evaporation with $Z_o= 0.01$ m for air passing over the water; previous work [1,2] has shown this to be a reasonable choice. Figure 27 shows the model superimposed on the pan evaporation for Sarsfield.

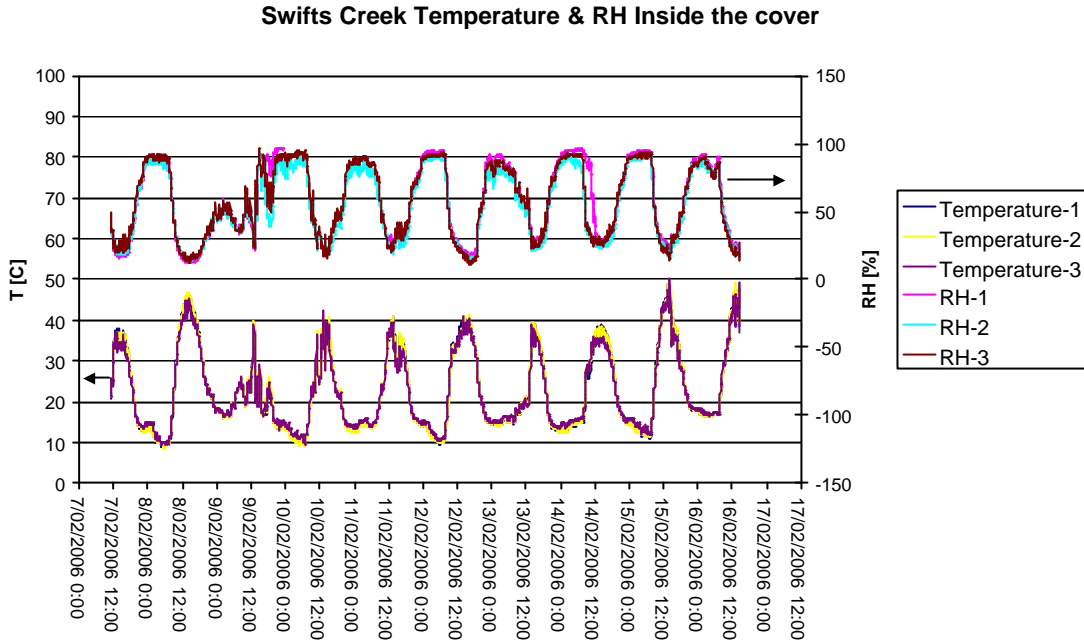
Figure 28. Air Temperature and Relative Humidity inside the cover at Swifts Creek at three locations 100mm below the cover.

Measurements of the temperature and humidity in the air column between the water surface and the cover were used to quantify the vapour transfer rate between the water surface and the cover. Water vapour will diffuse down the vapour pressure gradients but this flow is much smaller than the moisture transport due to wind. The difference in vapour pressure between the inside of the cover and outside is much smaller than that between the open water surface and the wind. However, this slow diffusion can be more constant than the wind, which may be intermittent. If there is no wind diffusion is still present. Figure 28 shows the RH and temperature 100mm below the cover at three

locations at Swift's Creek. This was collected with free standing USB data-loggers. Figure 29 shows the water vapour pressure calculated from these data and from the outside RH and Temperature at the land weather station nearby.

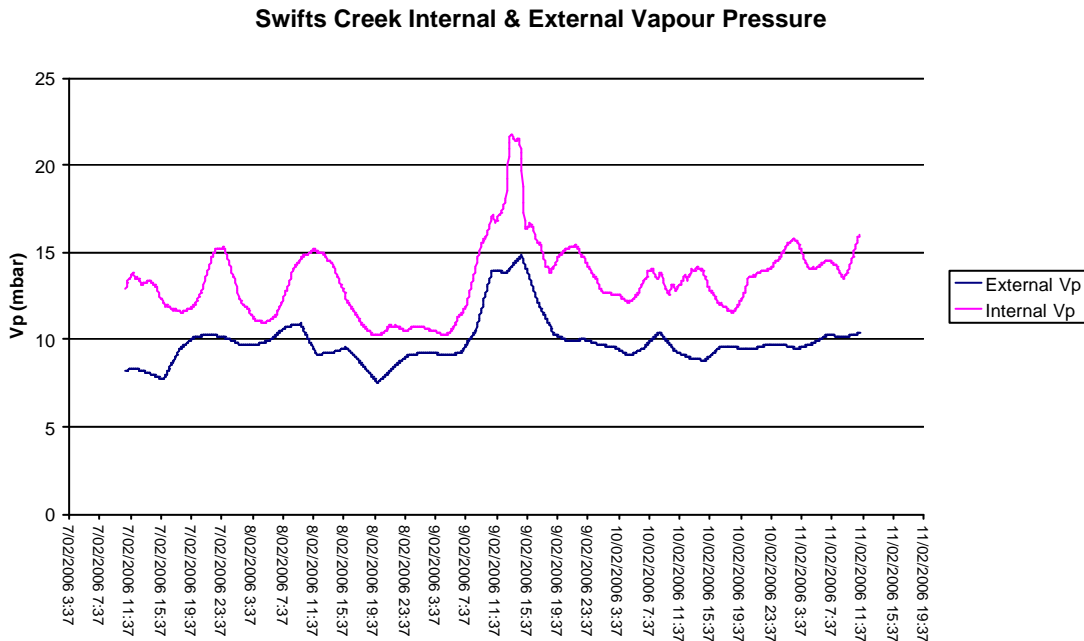
Figure 29. Water vapour pressure (Vp) inside and outside the cover at Swifts Creek. Outside Vp is calculated from the land weather station's Relative Humidity and Temperature.
