THE BENEFITS OF SHADE-CLOTH COVERS FOR POTABLE WATER STORAGE

Dr Niall Finn
Scott Barnes

CSIRO TEXTILE & FIBRE TECHNOLOGY

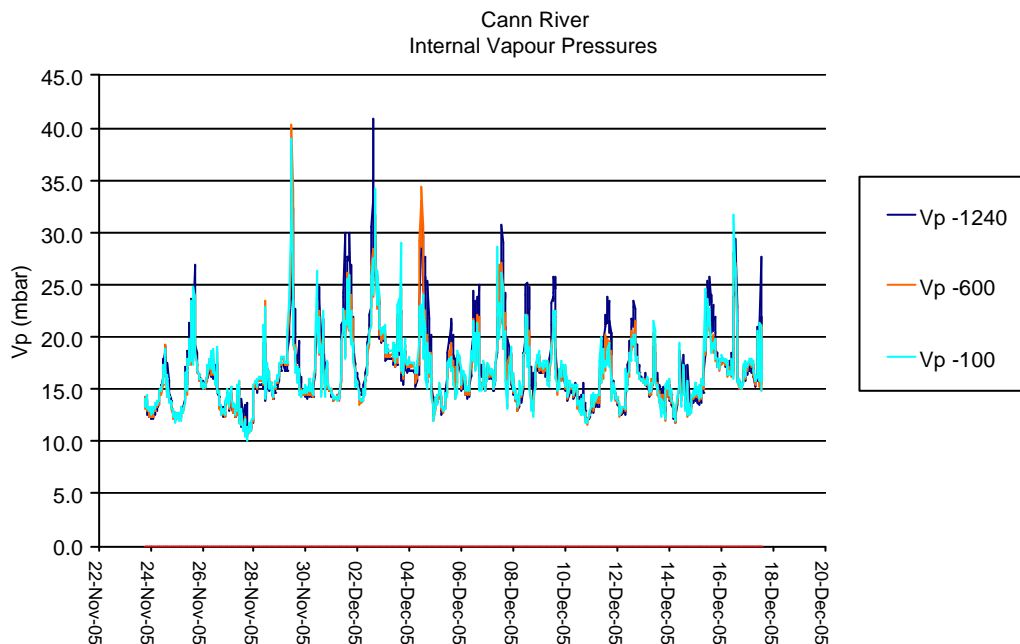
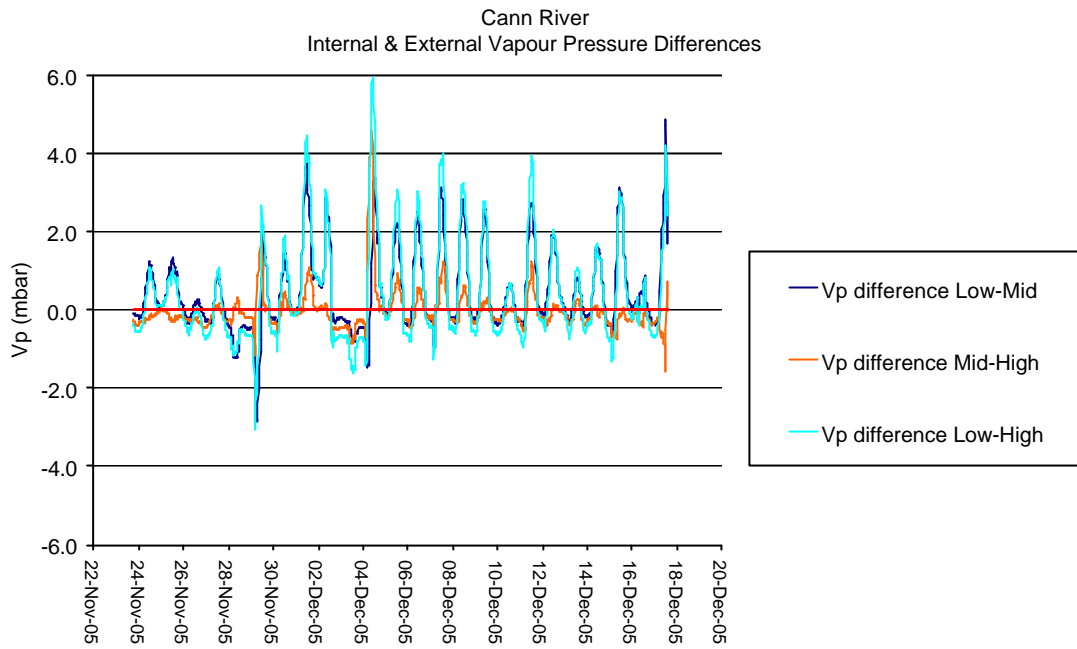
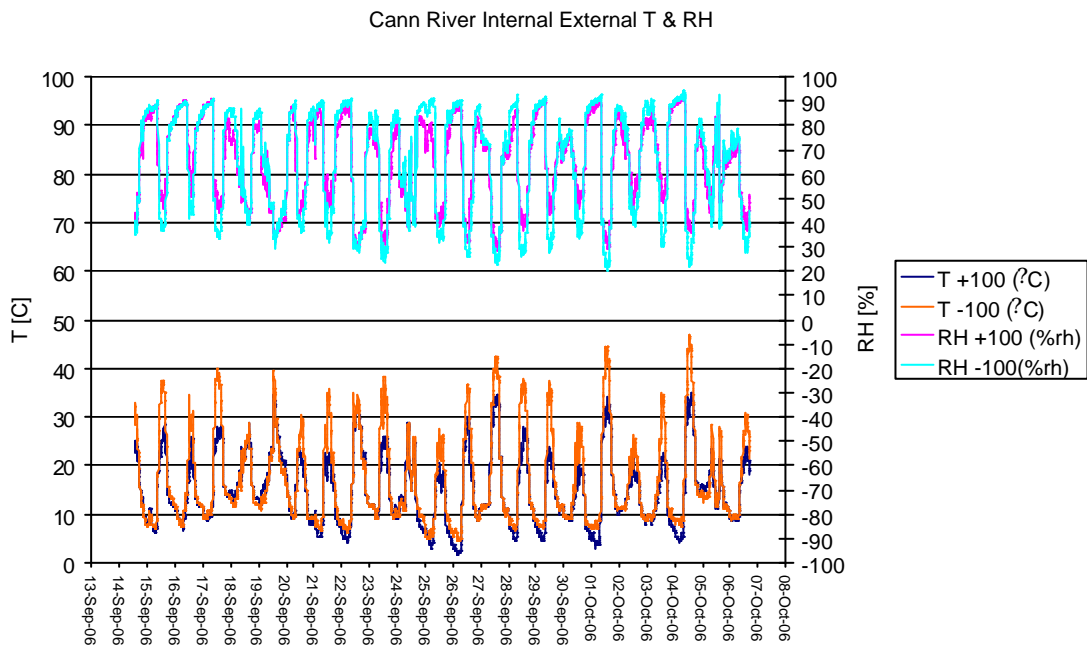
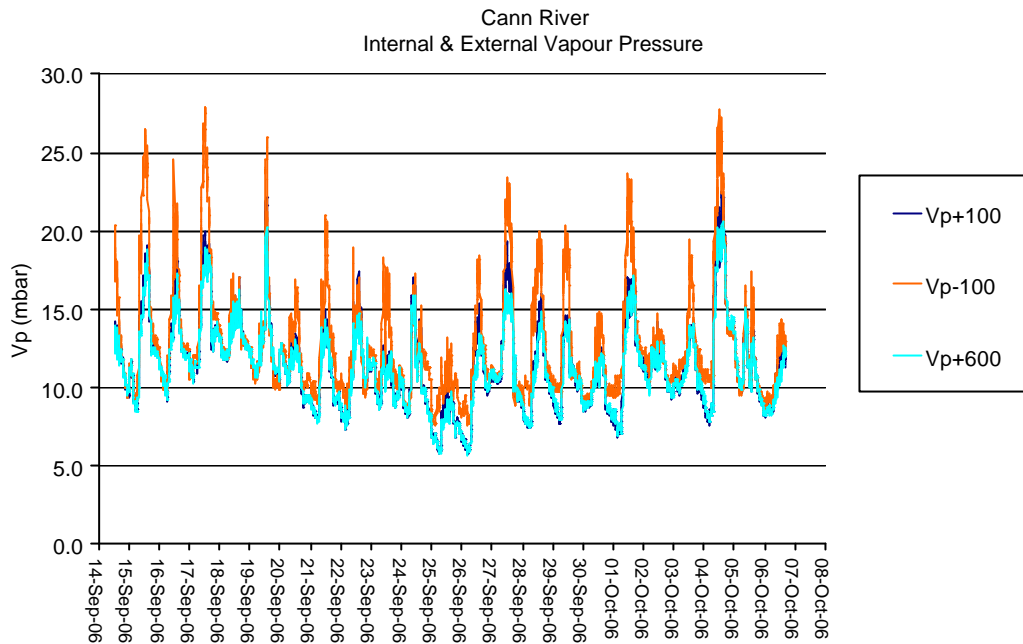
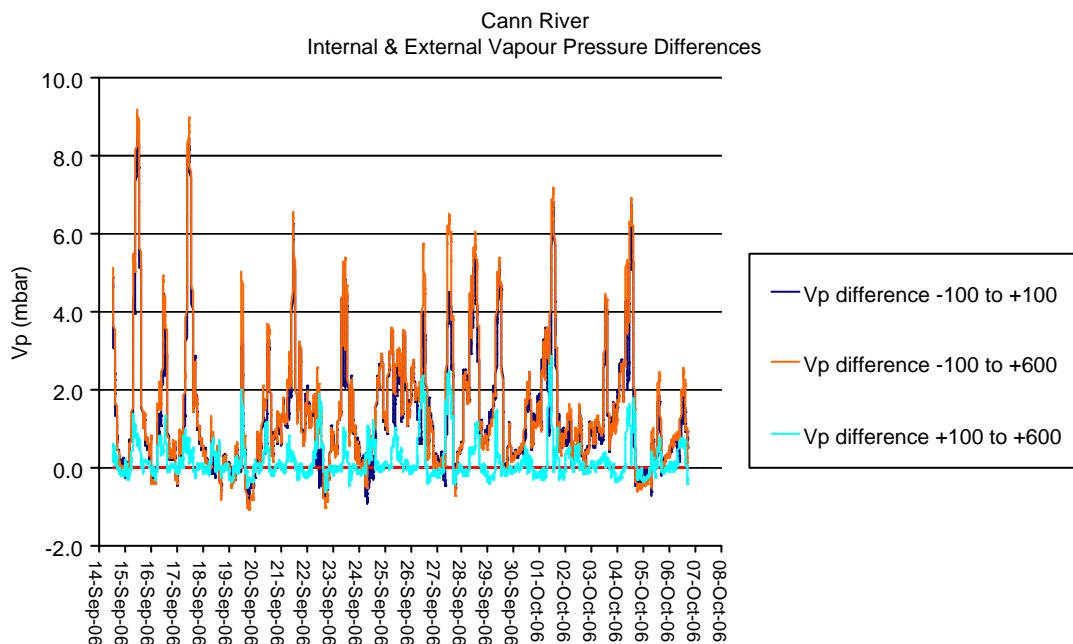
Figure 30. Vapour pressures inside the cover at Cann river, 100 mm below, 600 mm below and 1240 mm below the cover.

Figure 31. Vapour pressure differences inside the cover at CannRiver, 100 mm below, 600 mm below and 1240 mm below the cover.

Figure 32. Cann River Internal and External RH & temperature. (+100 denotes above the cover, -100 denotes below the cover)

Figure 33. Cann River vapour pressures 100 mm below, inside, and 100 mm and 600 mm above, outside the cover.

Figure 34. Cann River differences in vapour pressure between the inside (-100) and outside the cover and between close to the cover (+100mm) and well above the cover (+600mm).

Similar data were obtained at Cann River where Relative Humidity & Temperature monitors were positioned at a range of heights above and below the cover. These data suggest that there is a low vapour pressure gradient between 100 mm below and 600 mm below the cover and a small gradient between 600 mm and 1240 mm below the cover (see Figures 30 & 31). Loggers were also later placed 100 mm above, 600 mm above and 100 mm below the cover at the same locations. These results are shown in Figures 32 to 34 below and it can be seen that there is often a positive vapour pressure gradient driving moisture through the fabric but it is much less than that which often occurs between open water and the ambient air. A calculation similar to that performed for Swifts Creek using internal and external vapour pressures, wind speed and constants used for open water evaporation yielded a similar low value for evaporation through the cover even without including low fabric permeability.

Figures 30 to 34 show the vapour pressure gradients down which moisture diffuses from the water surface to the outside. This shows that there are some losses but they are very

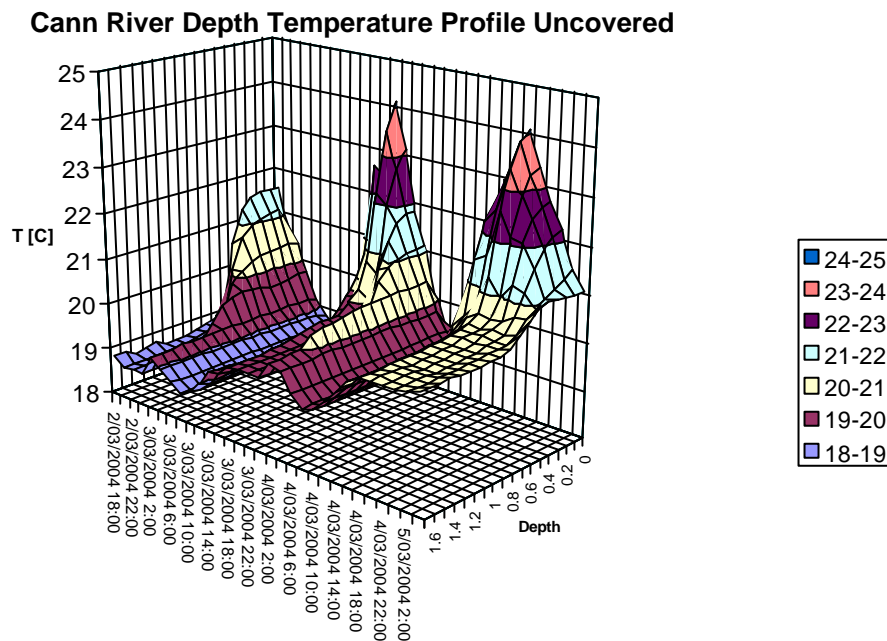
Figure 35. Cann River depth-temperature profiles prior to covering the basin, March 2004.

In the depth temperature profiles shown in Figure 35 from Cann River the axis shows a depth of 0.0 m at the surface and the water was 1.7 m deep at this time. Before the basin was covered the solar radiation during the day penetrates quite deeply into the water heating the surface layers up to 3 or 4°C warmer than the deeper waters and to a depth of 0.5m or more. The heat is lost during the night through conduction, radiation and evaporation. Although large temperature gradients can be generated in uncovered basins they do not last for long as heat is quickly lost and temperatures equilibrate. Rapid cooling of the surface could also result in a reversal of the temperature gradient that will then result in up-welling of the warmer water and mixing of the layers and can also lift sediments.

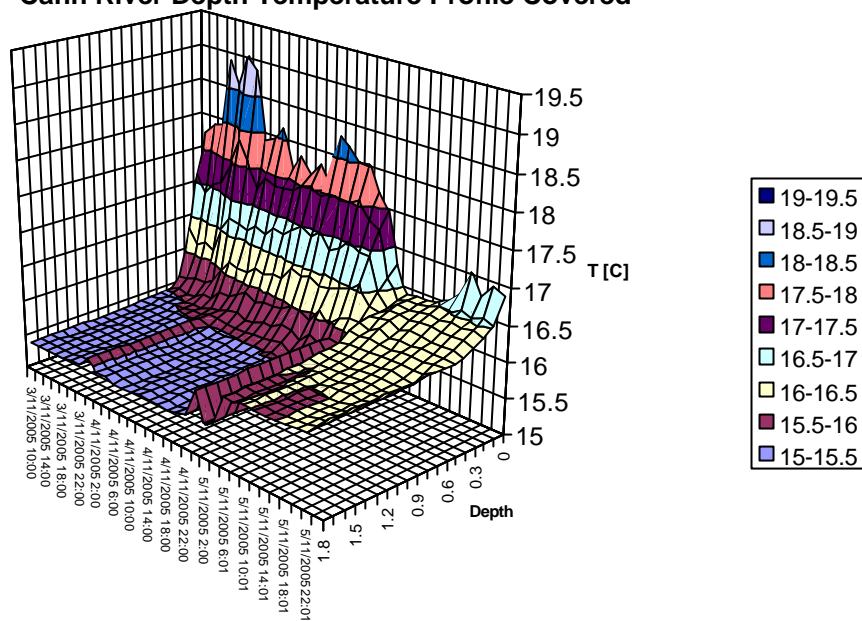
Figure 36. Cann River depth-temperature profile after the cover was installed. The temperature gradient while lower and shallower, persists for several days due to the insulating effect of the cover and reduced evaporation, Nov 2005

The periods of time for the depth profiles of covered basins were chosen for similar weather conditions to the uncovered examples shown. When the basin is covered with shade cloth (e.g. Figure 36 for Cann River and Figure 39 for Swifts Creek) the direct radiation is reduced by approximately 98% and the water is only heated by the residual direct radiation, radiation from the heated fabric, and conduction and radiation from the heated air under the cover. The cover also provides some insulation and prevents evaporation reducing the heat losses. The water therefore remains slightly cooler under the cover and while temperature gradients are smaller they can be more stable and longer lasting. After covering at Cann River a problem arose with iron contamination being pumped from the primary water source, a local river. The cold contaminated inlet water sank as it was fed into the basin and formed a layer of high iron content water at the bottom that was not readily oxidised. To remove this problem an aeration system was installed that mixed the water with high efficiency and resulted in efficient aeration at the surface. This also served to remove temperature gradients (Figure 37) although they were not contributing to the iron problem.

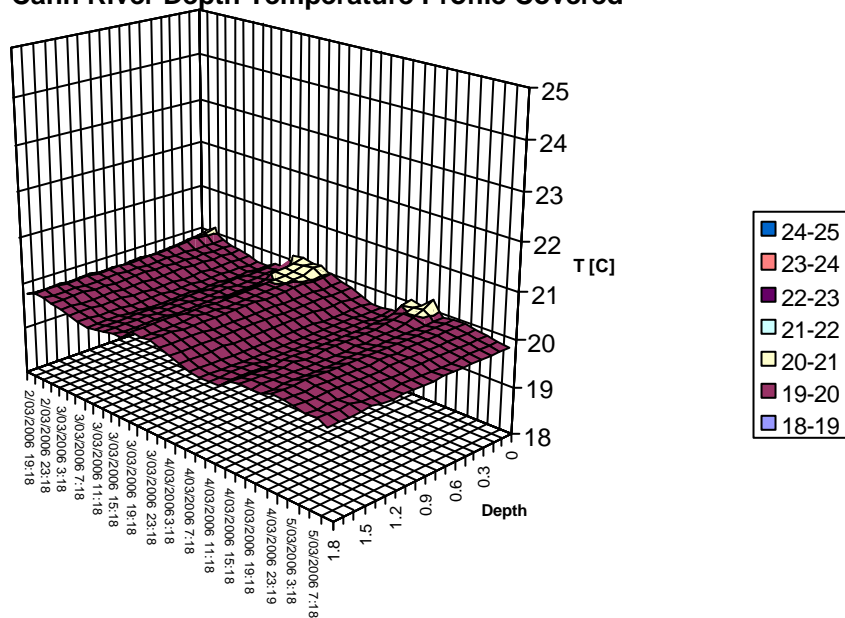
Figure 37. Cann River depth-temperature profiles after covering the basin to be compared with Figure 35 & 36. The basin was being aerated to remove iron contamination and this also eliminated the temperature gradients seen in Figure 35 & 36. It will be seen that other covered basins when not aerated (un-mixed) also display temperature gradients, e.g. Figure 39, and they last longer than when uncovered.

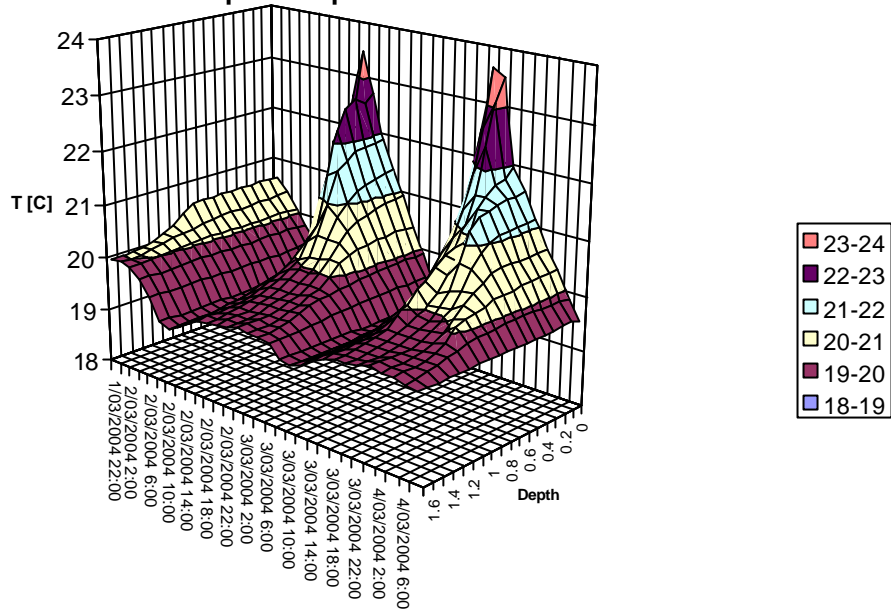
Figure 38. Swifts Creek Depth-Temperature profile before covering, March 2004.

Figures 38 and 39 are depth profiles for Swifts Creek again showing that when the basin is covered the temperature gradients are more stable and do not dissipate as rapidly as when uncovered. Since a large component of the cooling is evaporation this may constitute significant water saving but could also lead to undesirable stable stratification of the water body. However, the temperature gradients observed only lasted for a few days and when the weather cooled the temperature profile levelled out and the water temperature dropped. If temperature stratification were to become a problem then it is readily solved by mixing the water using submerged piping and compressed air as was done at Cann River. Other means of mixing the water can also be employed, which can also serve to aerate the deeper water. The main problem with a stratified water body is that a very cold anoxic layer can form at the bottom of the storage. However, this usually only occurs in deep basins. Layering occurred diurnally in uncovered basins and more stably in covered basins but this difference is not sufficient to conclude that stratification would be more problematic or prevalent in covered basins than in uncovered basins. Turnover events can also occur in water storages whereby the water body is heated to some depth but a cold snap then rapidly cools the upper layers and the warmer submerged water rapidly comes to the surface causing turbulence that may disturb sediments causing turbidity problems. One effect of the cover is to slow down the speed with which water temperature changes occur and so this type of undesirable event is unlikely to occur in a covered basin.

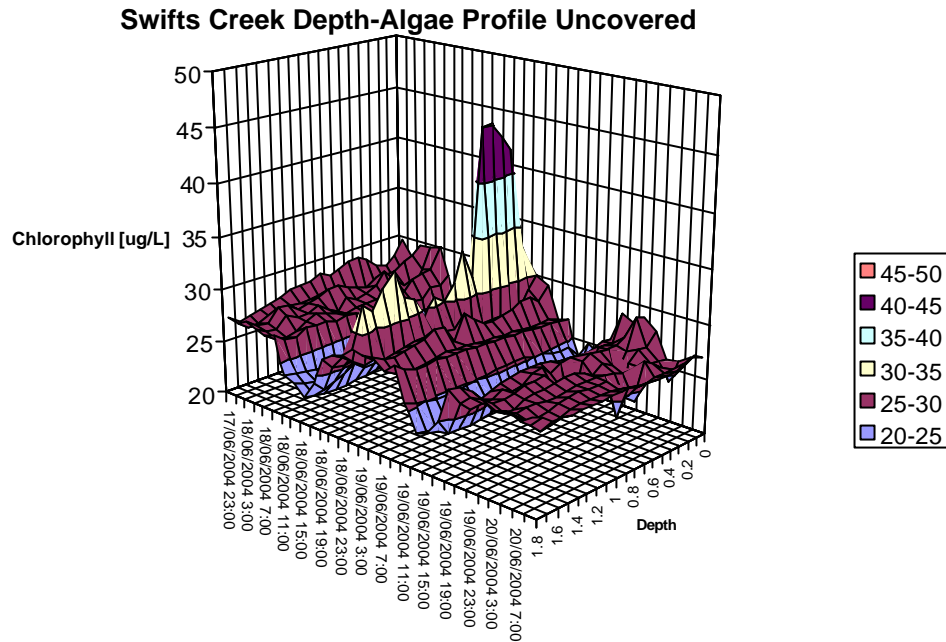
Figure 40. Swifts Creek Depth-Chlorophyll profile, uncovered, June 2004.

In Figure 40 the variation with depth of the chlorophyll signal during an algal event can be seen. A peak occurs for a short period near the surface but generally the algae appear to be quite evenly distributed through the water. Extremely brief and localised peaks were also occasionally observed at the surface but may have been due to floating debris or clumps of algae.

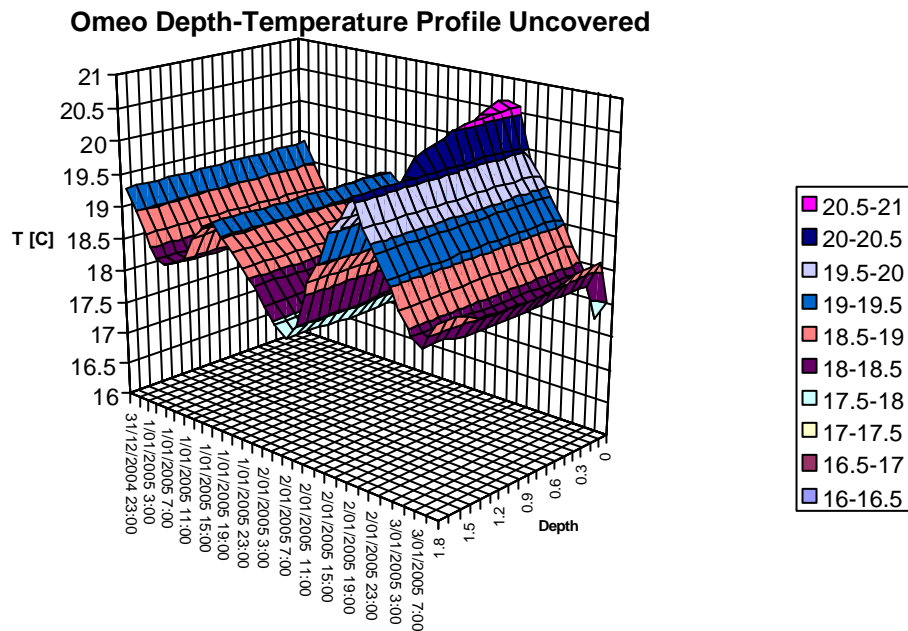
Figure 41. Omeo Depth-Temperature profile uncovered, December 2004 to January 2005.

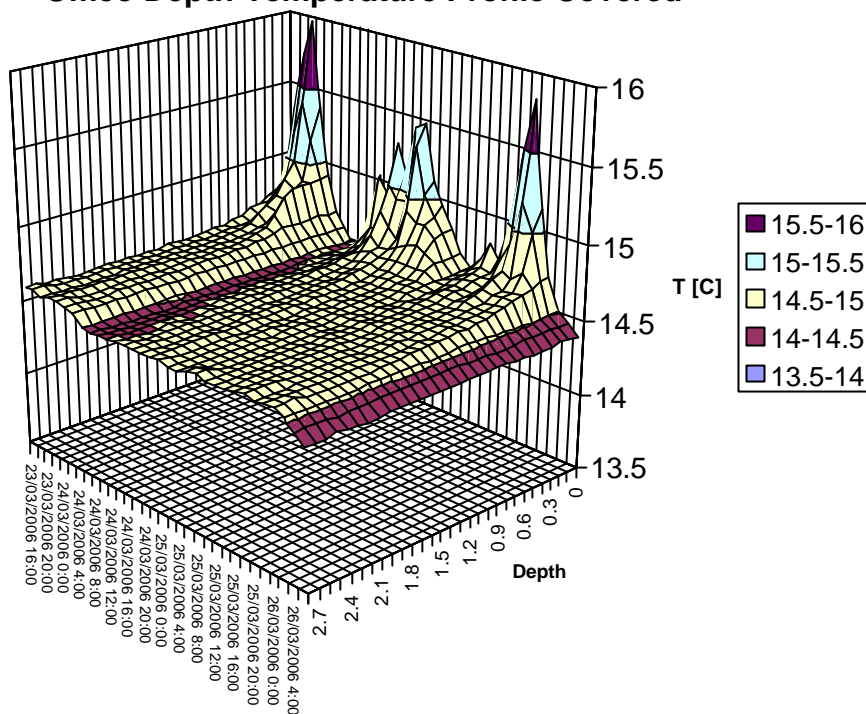
Figure 42. Omeo depth temperature profile after covering, March 2006.

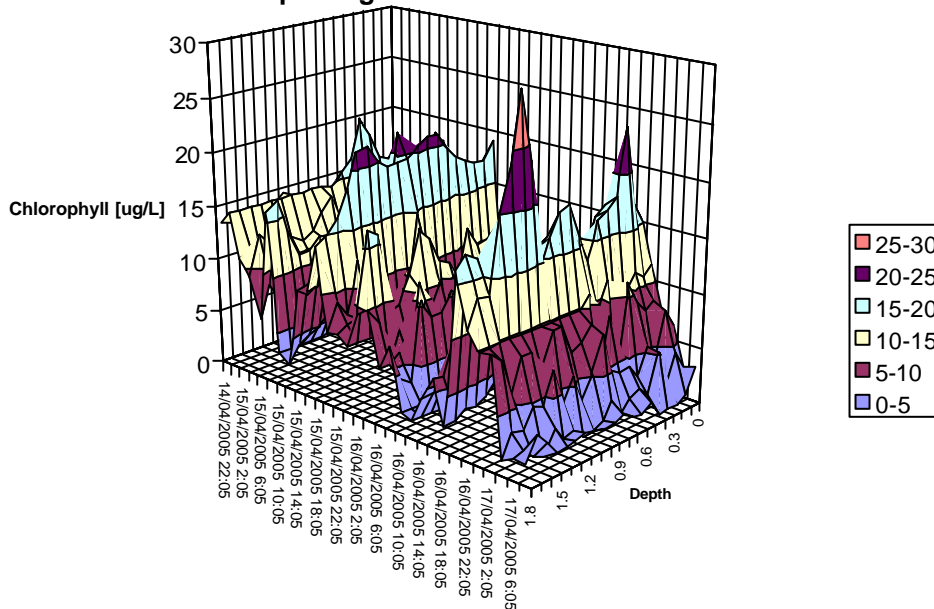
Figure 43. Omeo Depth-Algae Profile, April 2005.

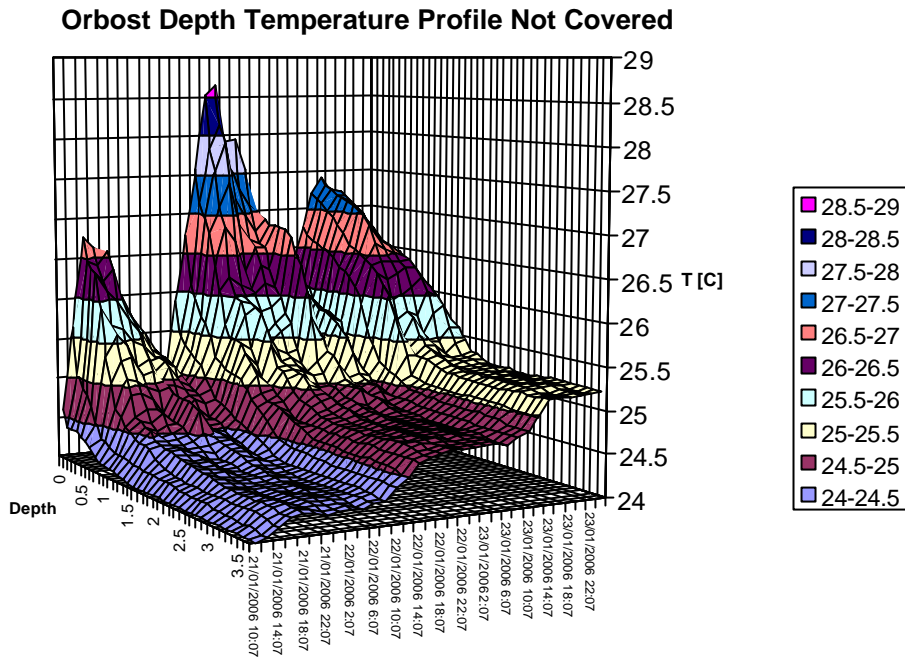
Figure 44. Orbost Depth-Temperature profile.

The depth-temperature profile from Orbost in Figure 44 shows how the temperature of the water body rises due to radiative heating at and near the surface with absorption falling roughly exponentially with depth. Heat then conducts slowly down into the deeper water.

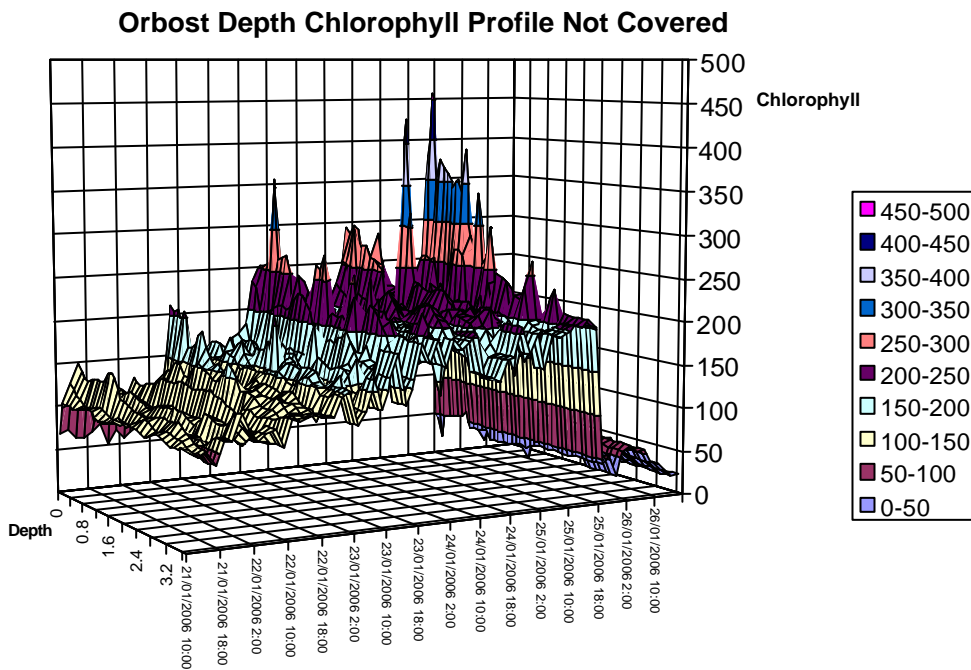
Figure 45. Orbost Depth-Chlorophyll profile January 2006.

Figure 45 shows the distribution of growth of an algal bloom at Orbest over six days in January 2006, the same time period as for Figure 44. The figure shows higher growth at the surface and the sudden dying out of the bloom 25 January. This event is also seen in Figure 24 in both the Minisonde chlorophyll signal and the laboratory test results.

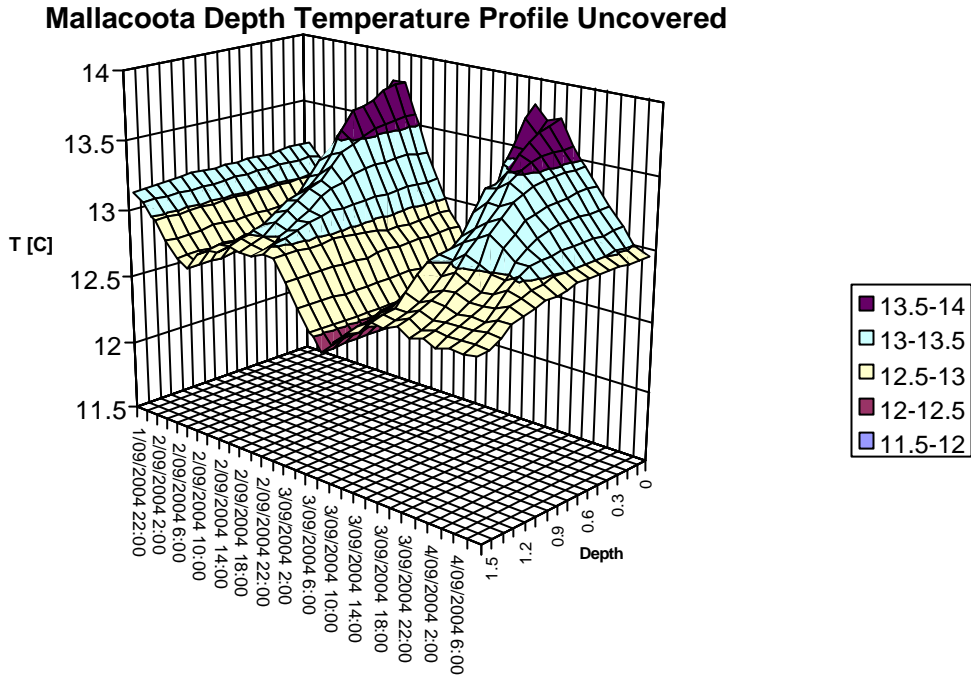
Figure 46. Mallacoota depth temperature profile before cover was installed

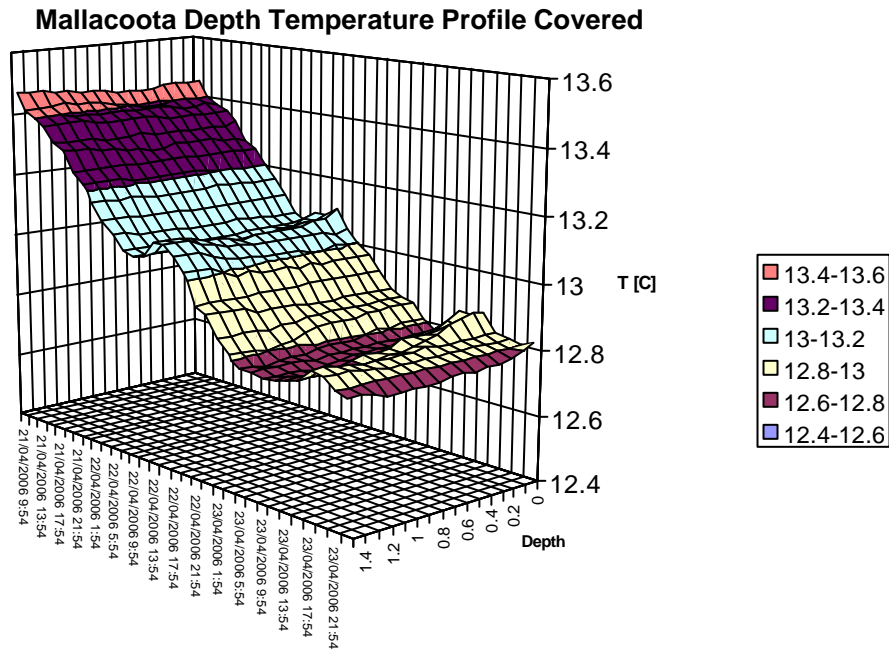
Figure 47. Mallacoota depth temperature profile after cover was installed.

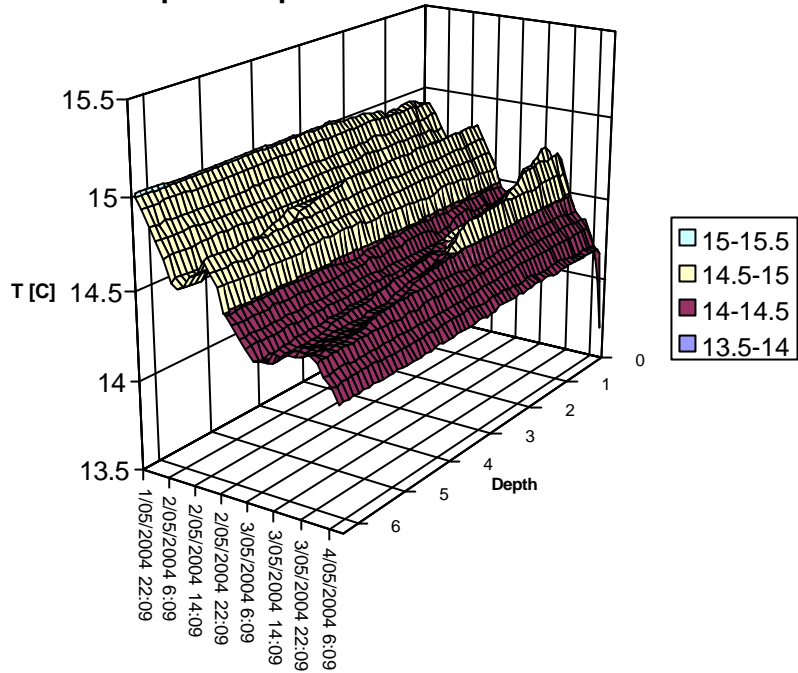
Figure 48. Sarsfield Depth-temperature profile. Sarsfield is the deepest basin at 6.5 m.

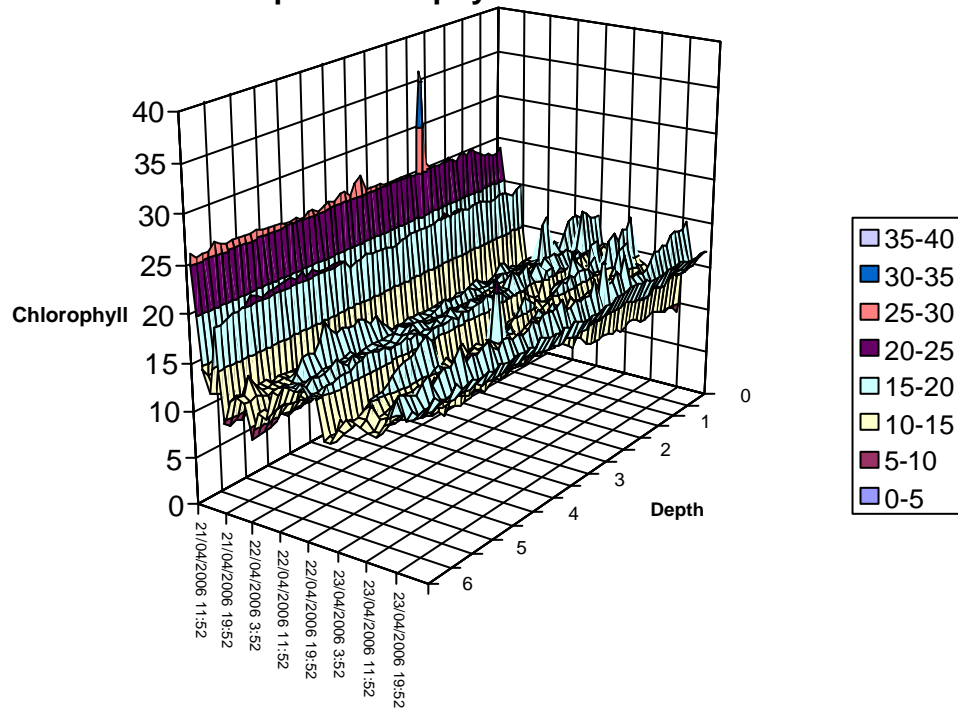
Figure 49. Sarsfield Depth-chlorophyll profile.

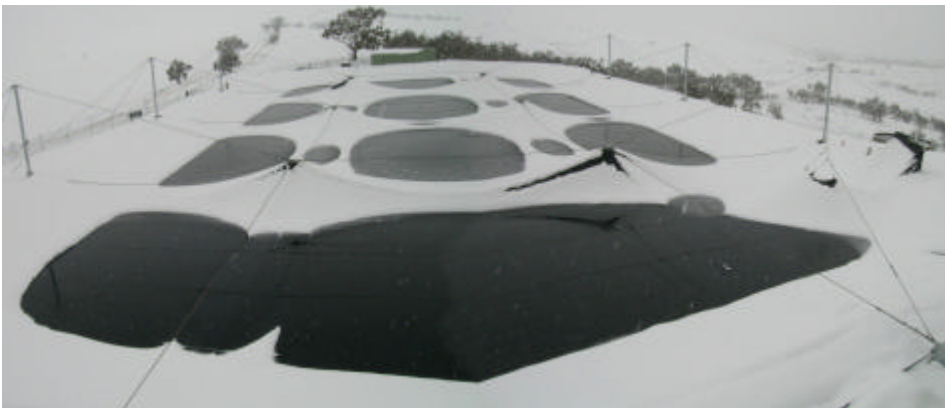
Figure 50. *Omeo after a heavy snow fall*

The problems with the covers discussed here are, however, minor issues compared to the successes seen since their installation. Omeo has withstood very high winds and heavy snow falls and no significant algal blooms have occurred in covered basins through the past summer. Bacterial counts have also been greatly reduced and seem now to relate entirely to pumping events at the Raw Water Storage basins (Cann River and Swifts Creek). At Mallacoota there is an ongoing problem with Diatoms (*Synedra* sp). These appeared to thrive in the Clear Water Storage even under low light conditions, possibly due to the levels of silica present in the storage that served as 'building blocks' for their silica 'shell'. This hard silica shell can cause problems in a water treatment plant by adding to filter blockages and increasing backwash operations. Increased backwash cycles increases the amount of water 'wasted' at the plant and lowers the volume of water produced. It may be possible to filter them out at the inlet to the basin and the outlet to the treatment plant. Filtering of inlet water at raw water storages could possibly allow the benefits of the covers to be more fully exploited, as they are at the clear water storages.
